approach

APRIL 1978 THE NAVAL AVIATION SAFETY REVIEW

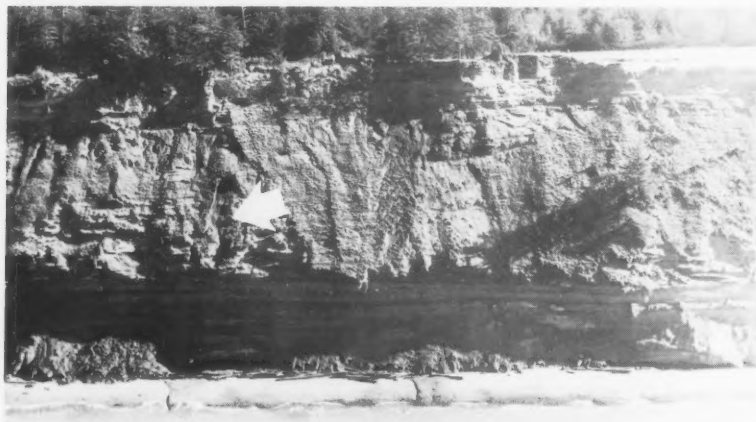
Arrow indicates location of boy on dead tree.

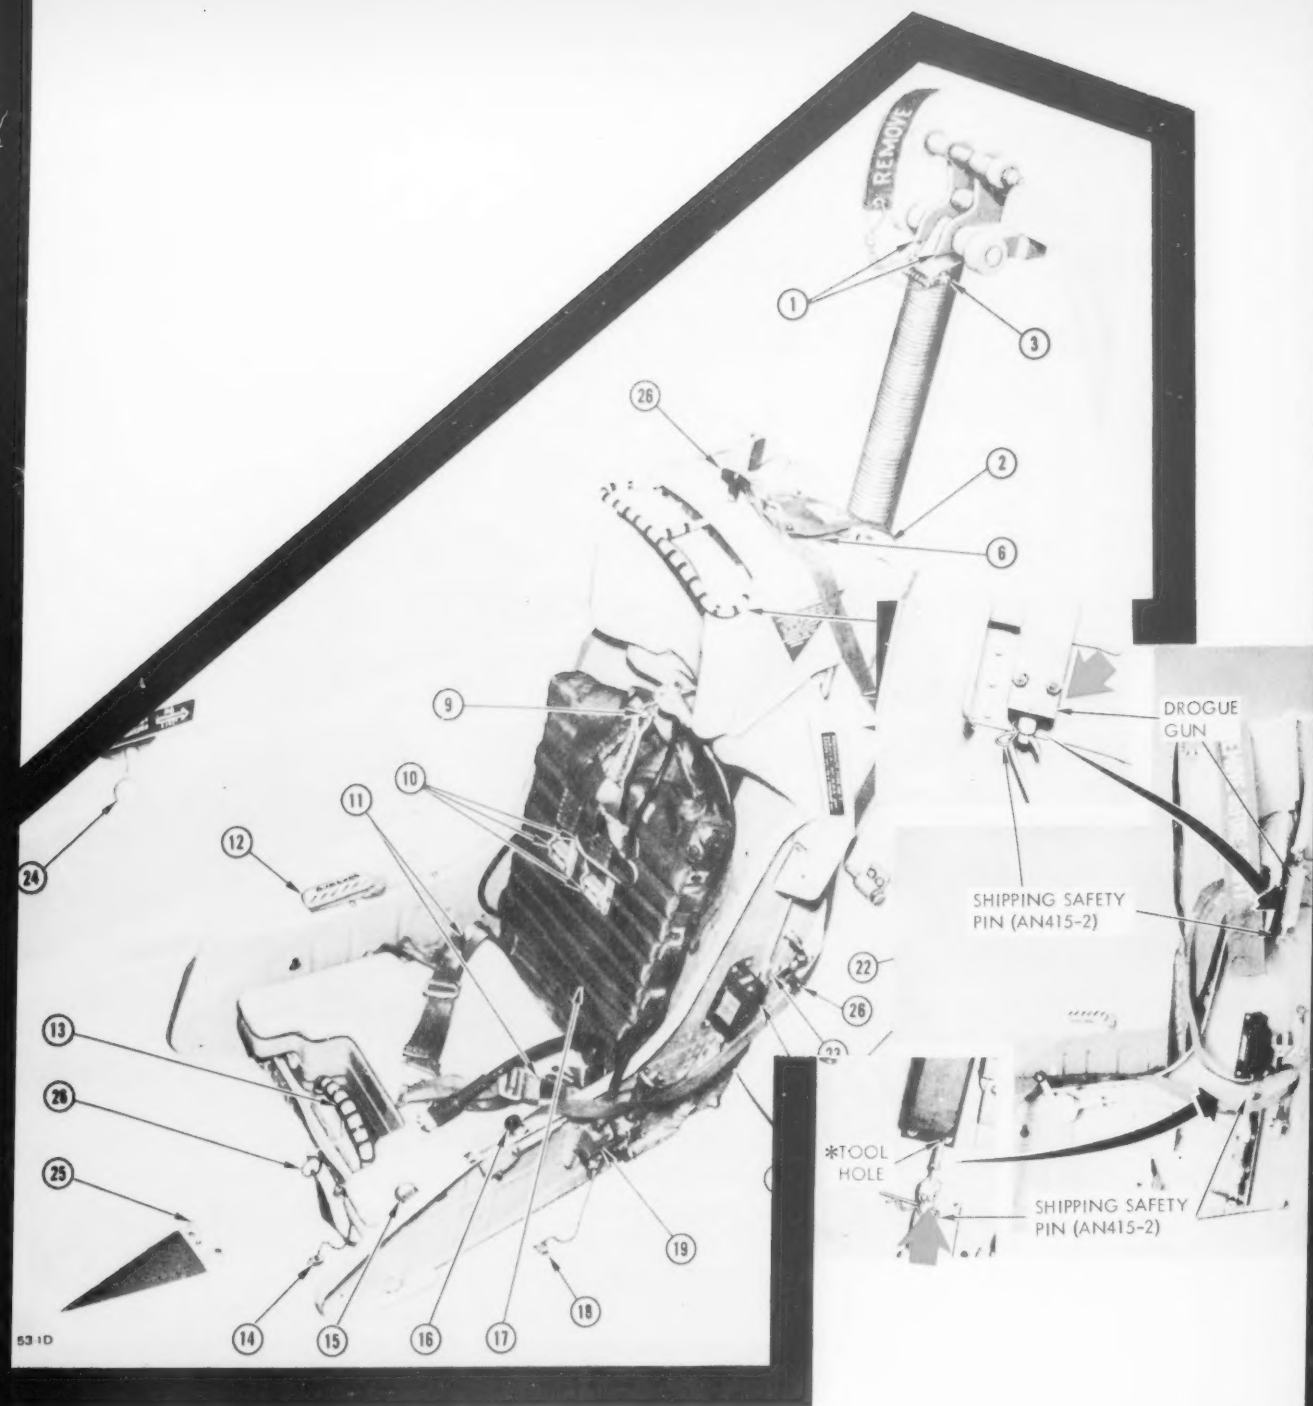
One might ask how two safety pins could be missed by two QARs, one CDI, one plane captain, one final checker, and two pilots. Haste, certainly, was a factor, but there was some additional "help." The pins are small and did not have individual flags, but were merely connected by a strip of (formerly) fluorescent orange tape that had been spray painted the same shade of gray as the ejection seat!

Green arrows identify the location of the two maintenance pins.

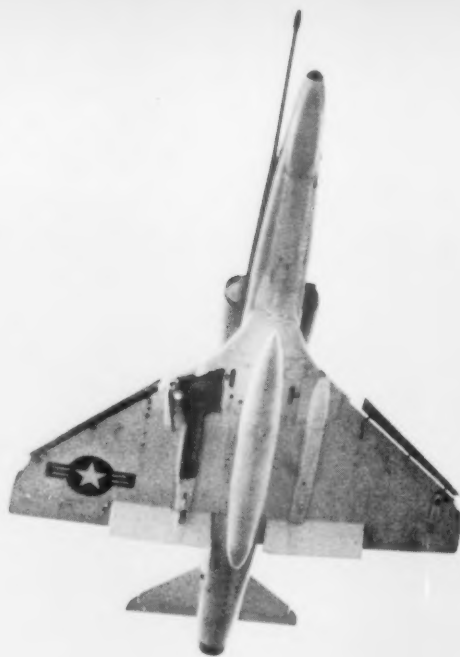
Main landing gear hangups due to deflated shock struts have been a recurring problem in the A-4.

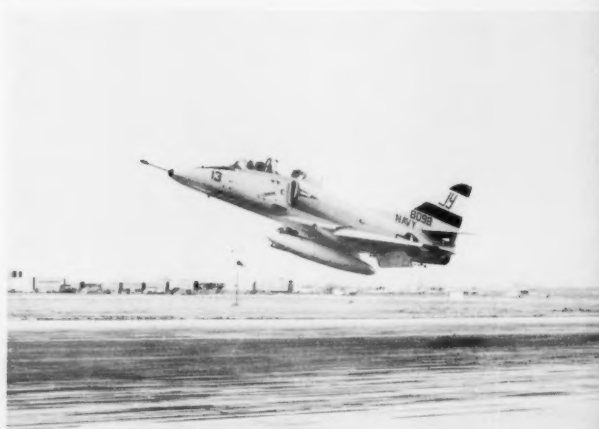
Experience has shown that wheels-up landings in the A-4 are relatively safe — even with only a centerline drop tank installed.

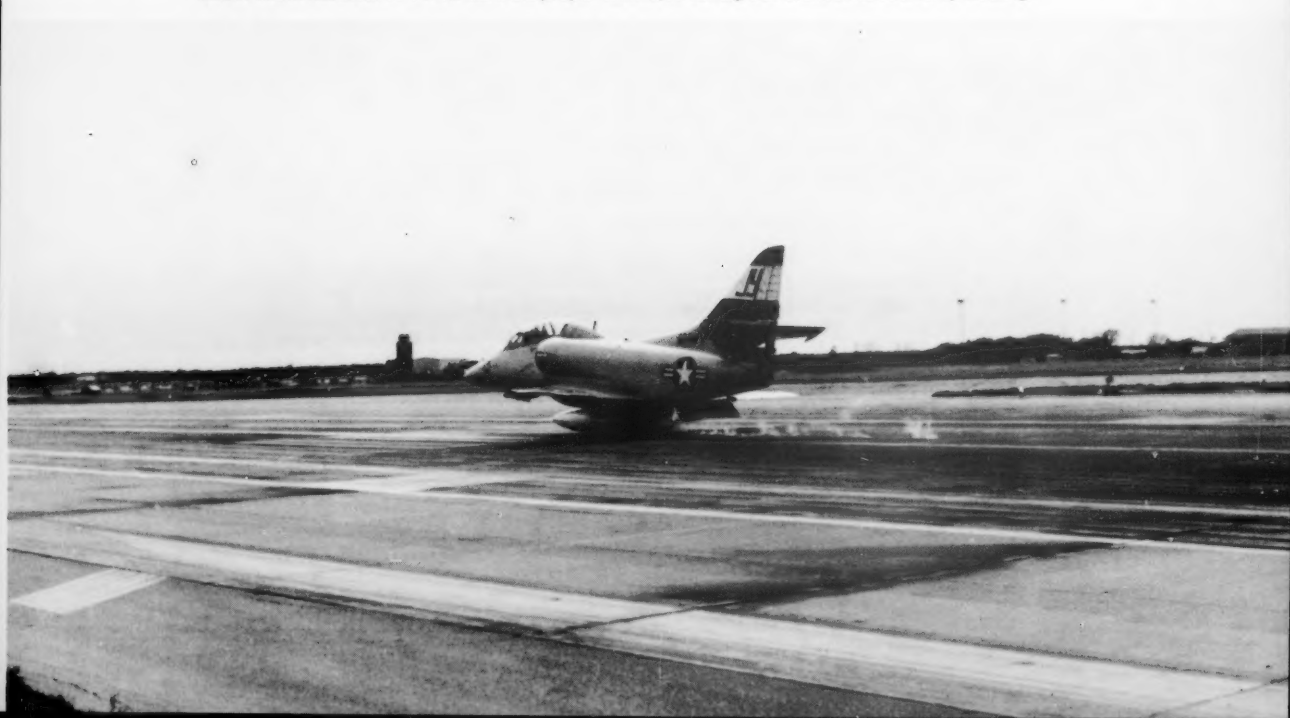
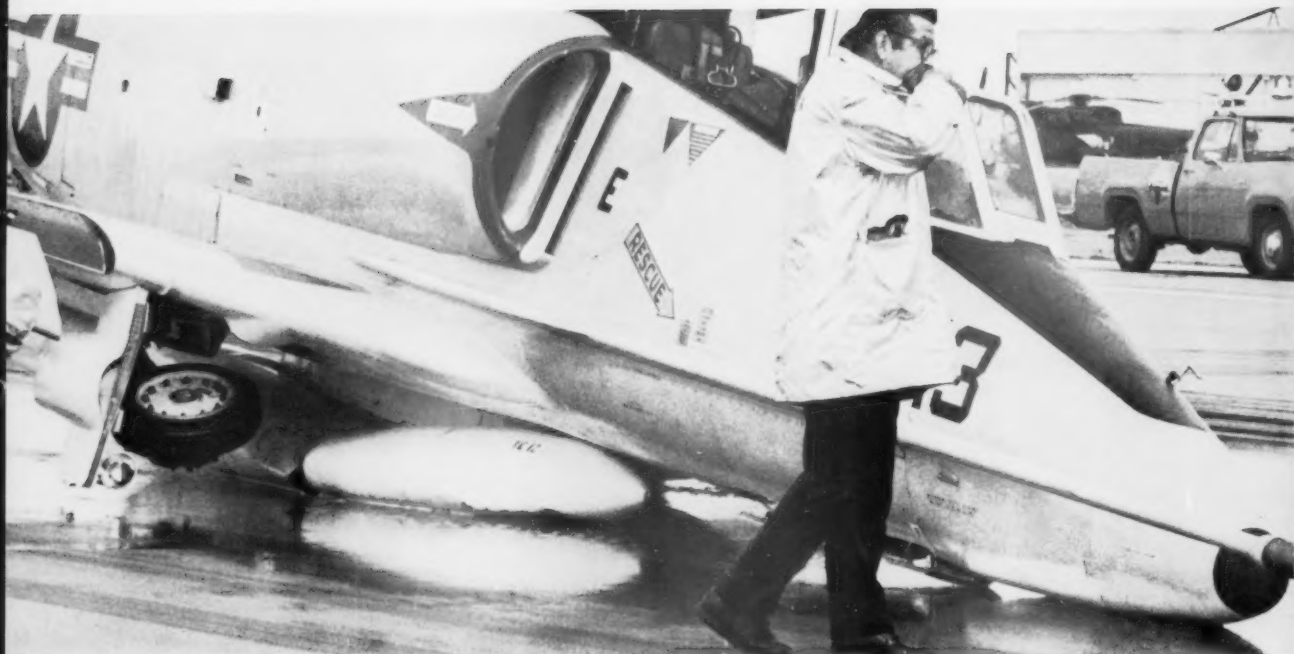
LCDR Norm Justesen of VC-12 used the proper technique during this intentional wheels-up landing.

Good pilot technique results in minimum damage for the wheels-up landing.

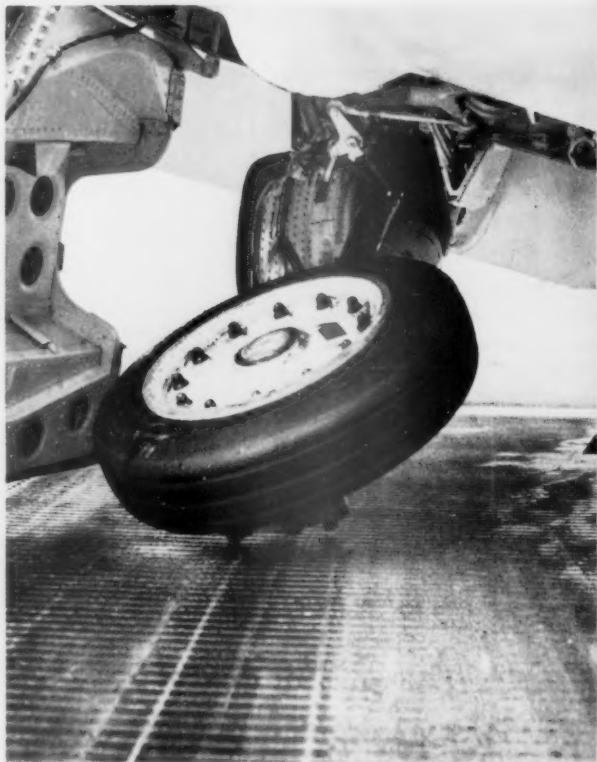
The culprit.

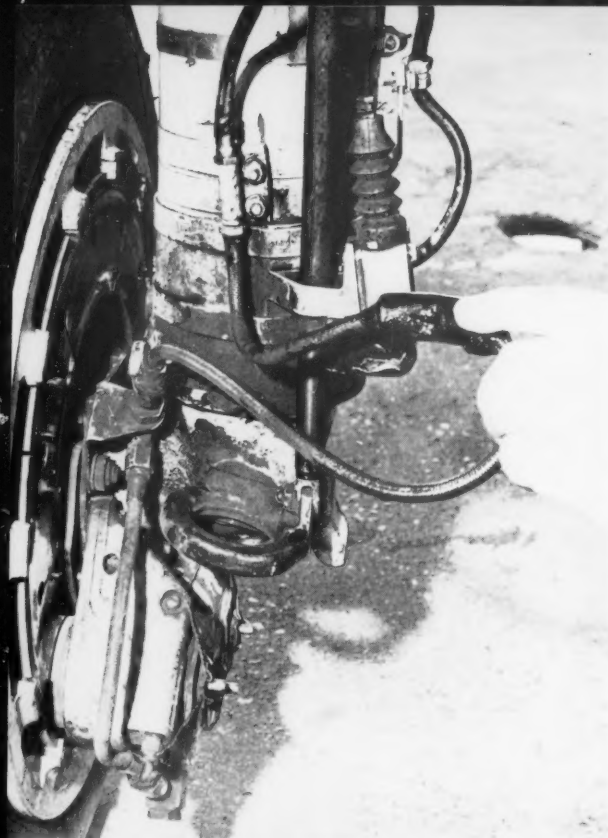
This brake hose frequently catches on some part of the wheelwell when the strut deflates.

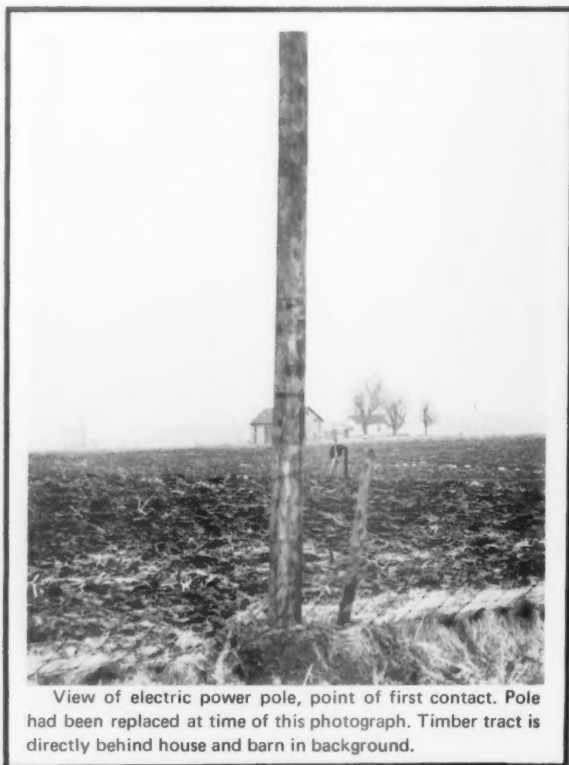
View of electric power pole, point of first contact. Pole had been replaced at time of this photograph. Timber tract is directly behind house and barn in background.

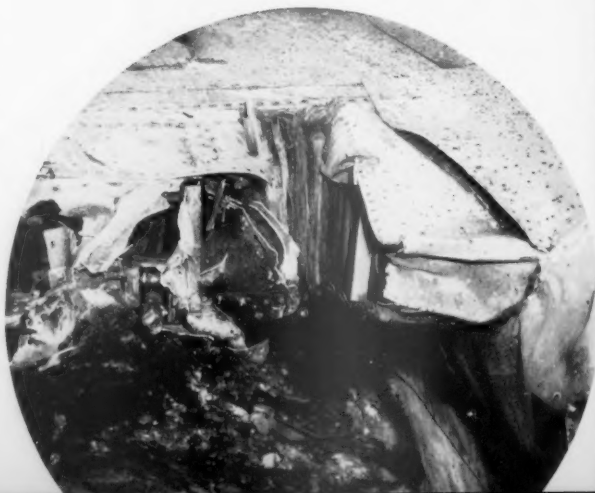
Port wing showing leading edge tree-impact damage. Speed brakes were fully extended, landing gear and flaps up.

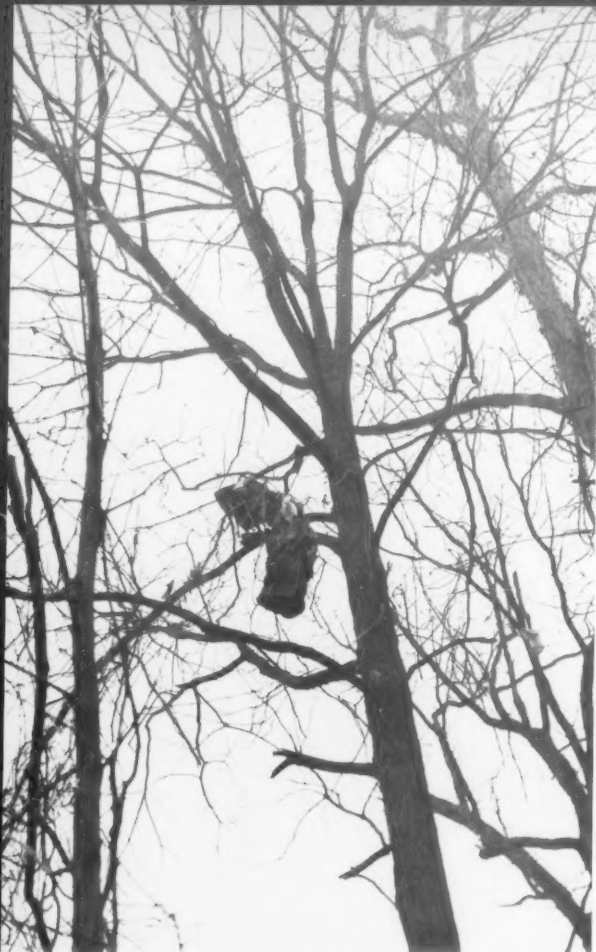
The pilot's suit bag was found in the approximate center of the timber tract.
